Lake Randolph

Summary of Survey Report and Recommendations

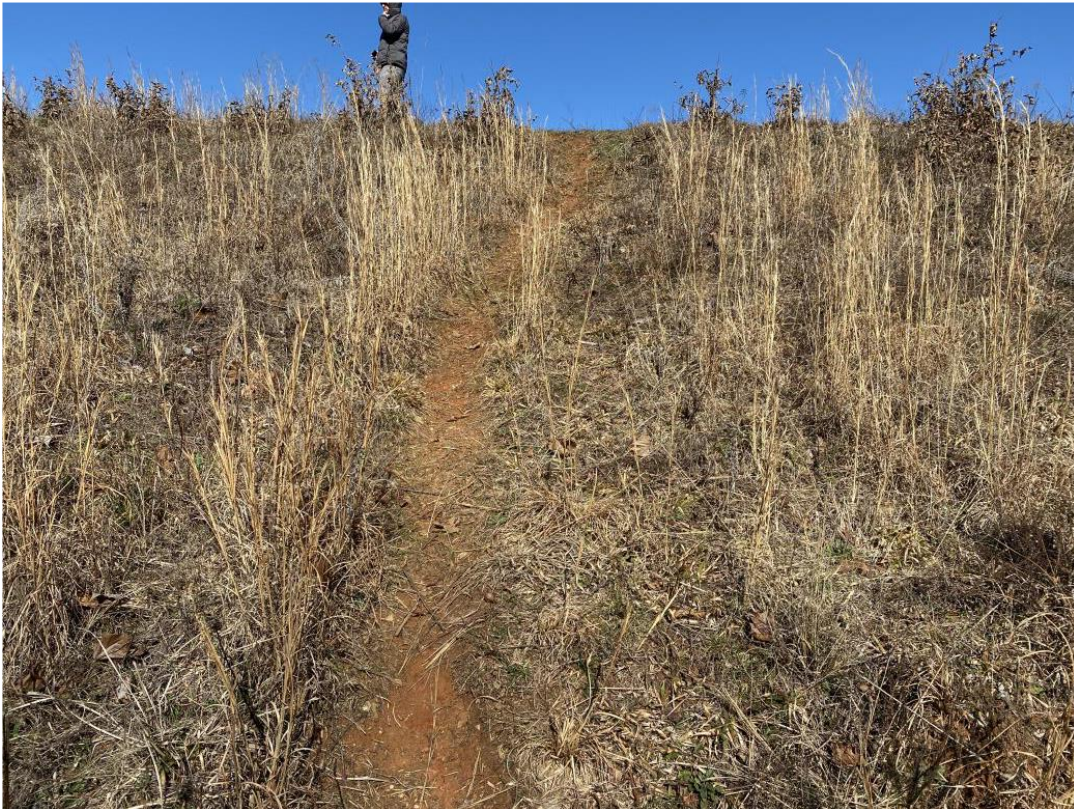
- Minor areas of erosion on downstream embankment slope (Fishing trail and deer tracks.)

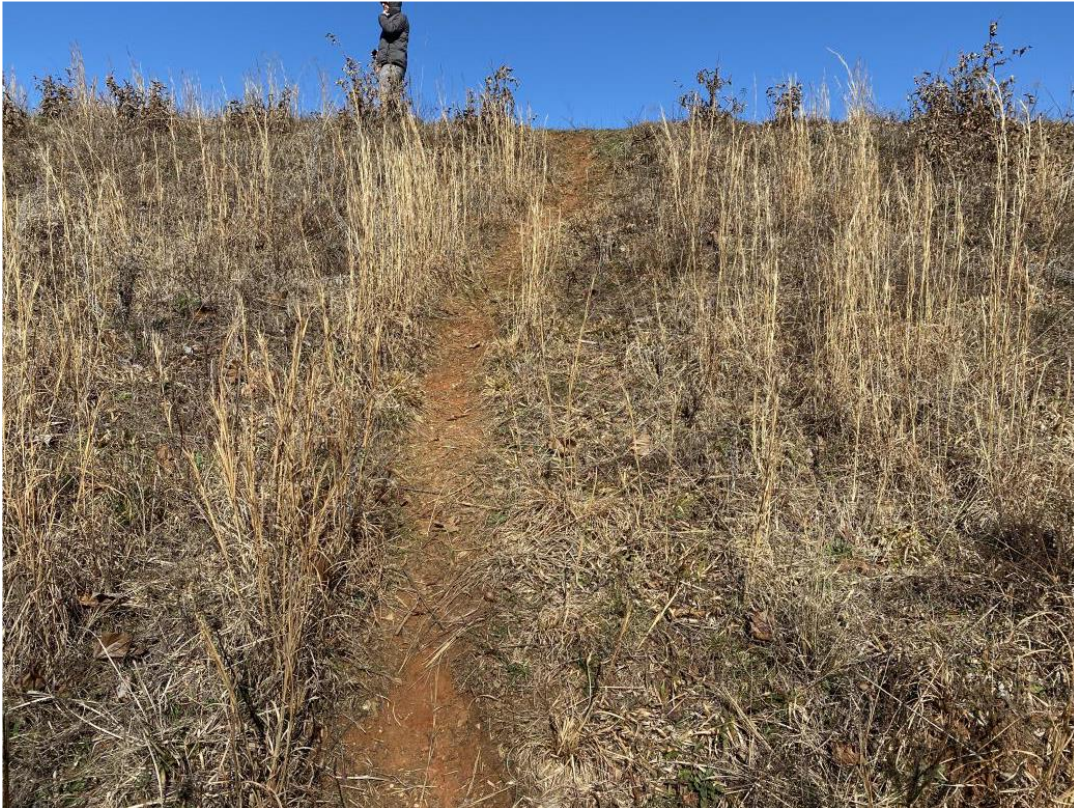
- Minor areas of erosion on downstream embankment slope (Fishing trail and deer tracks.)

Fill and seed

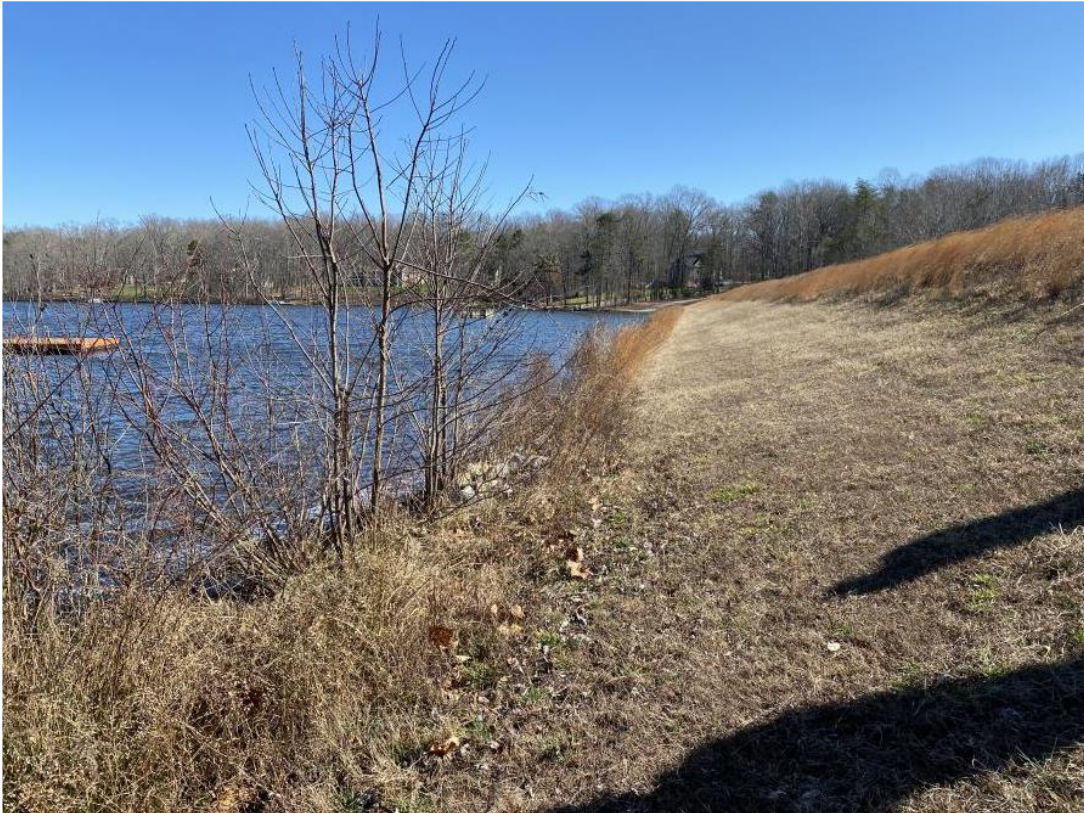
- Small woody vegetation amongst the riprap

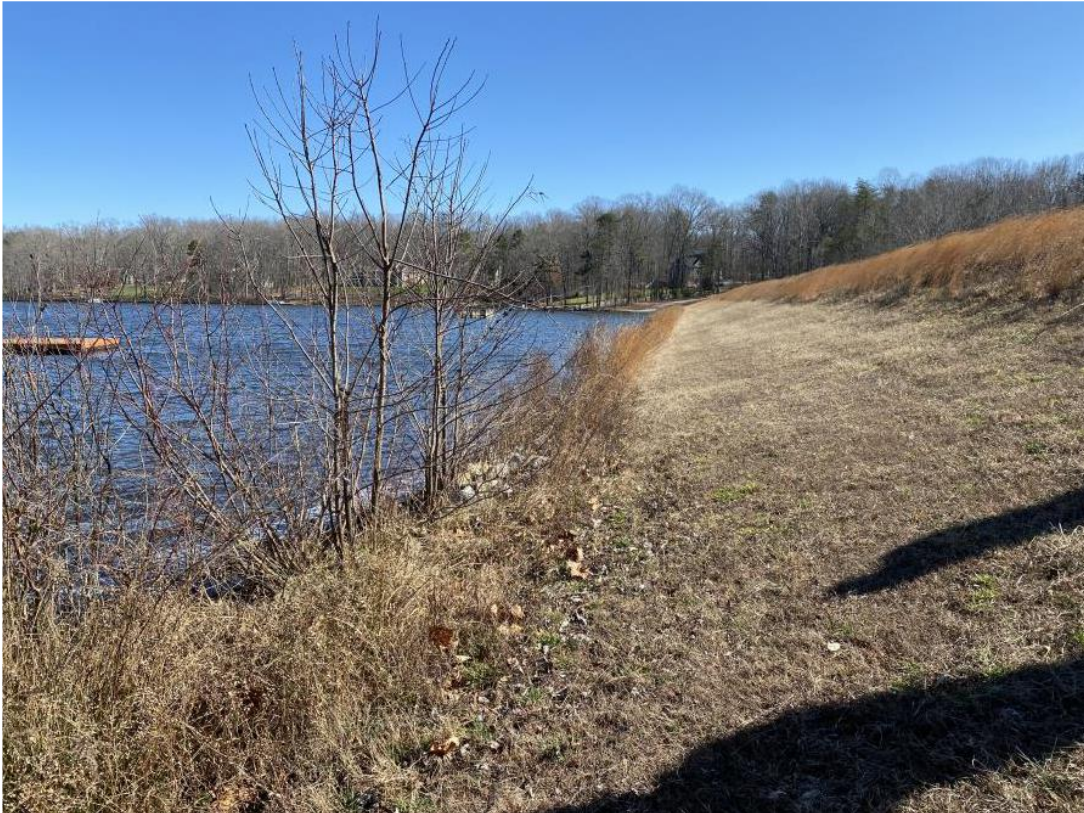
- Small woody vegetation amongst the riprap

Remove. Mow twice annually.

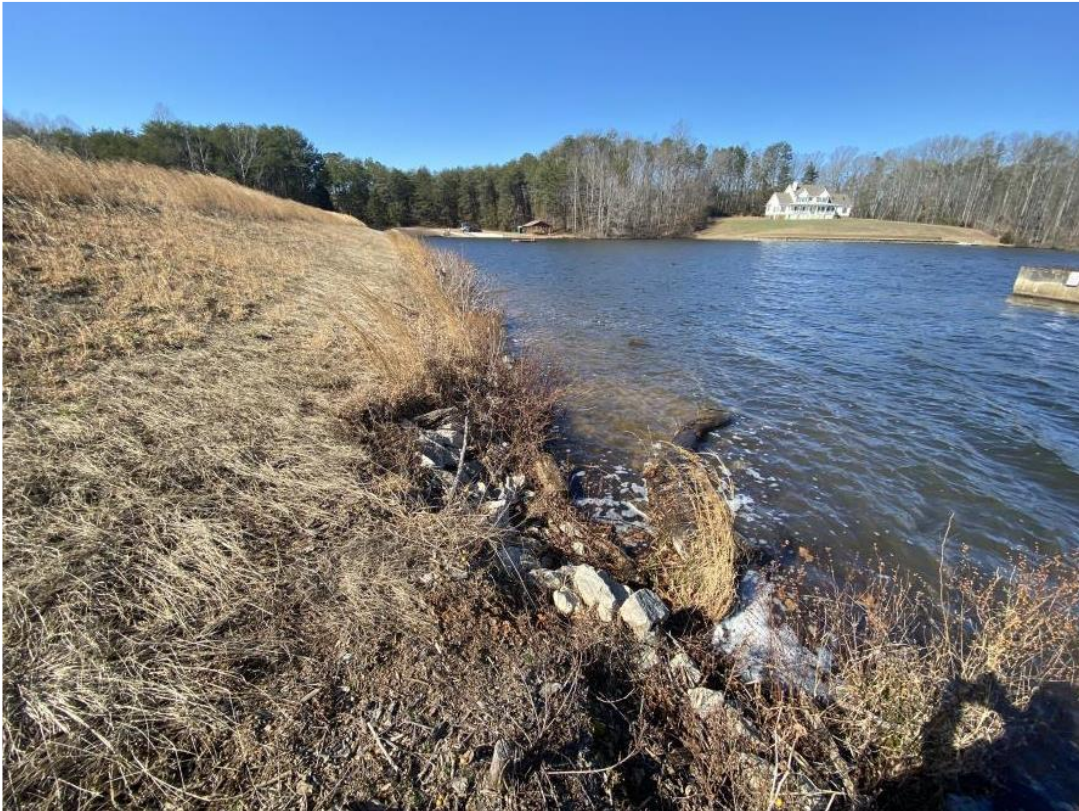
- Area of minor erosion along upstream shoreline

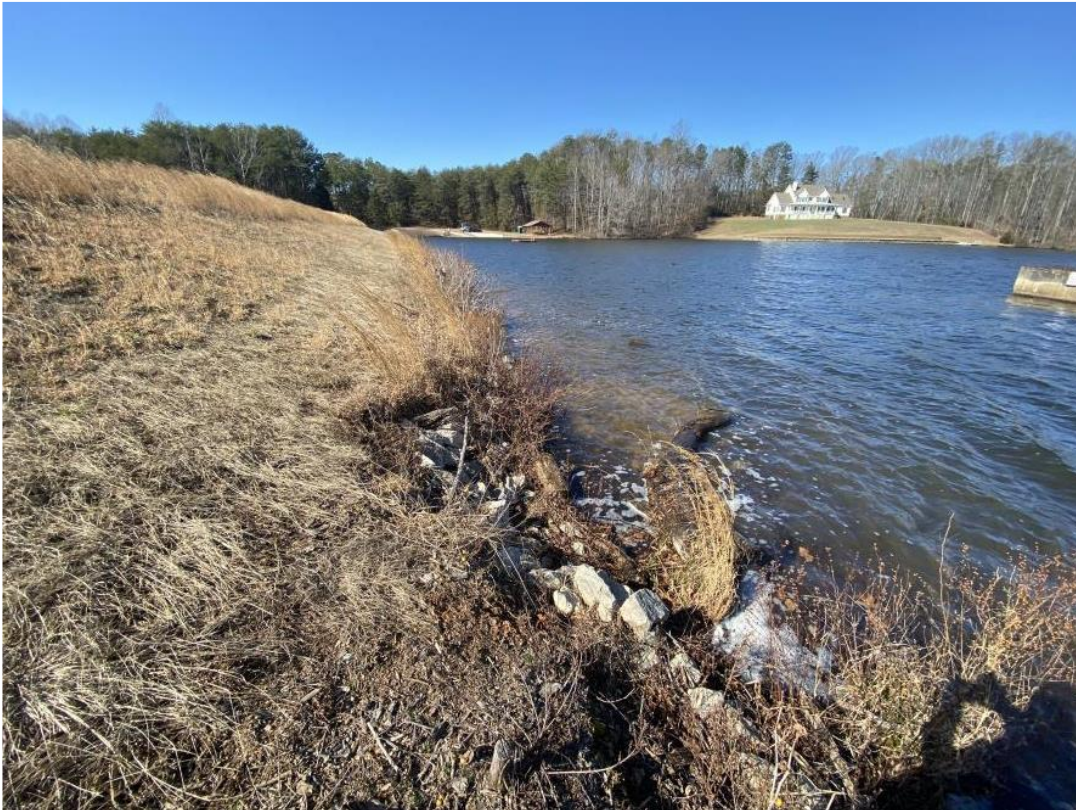
- Area of minor erosion along upstream shoreline

Monitor and maintain.

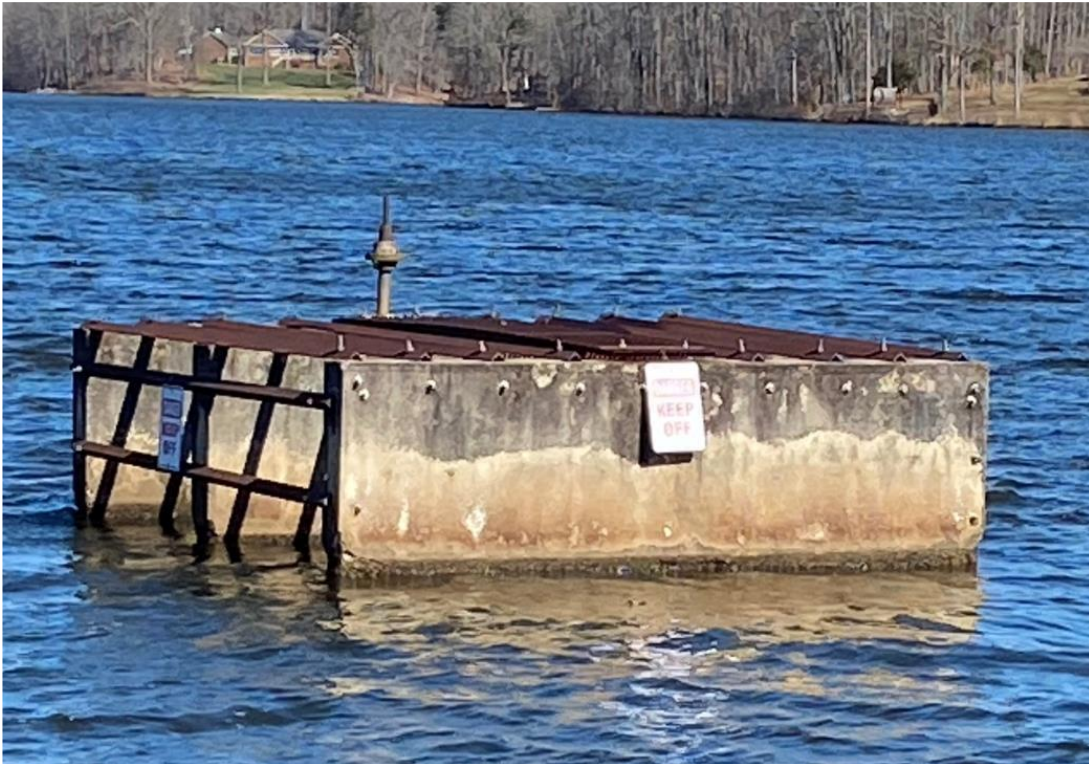
- Some minor areas of concrete spalling around the outside of the riser structure. No exposed rebar. Debris rack appears in good condition and operating as designed.

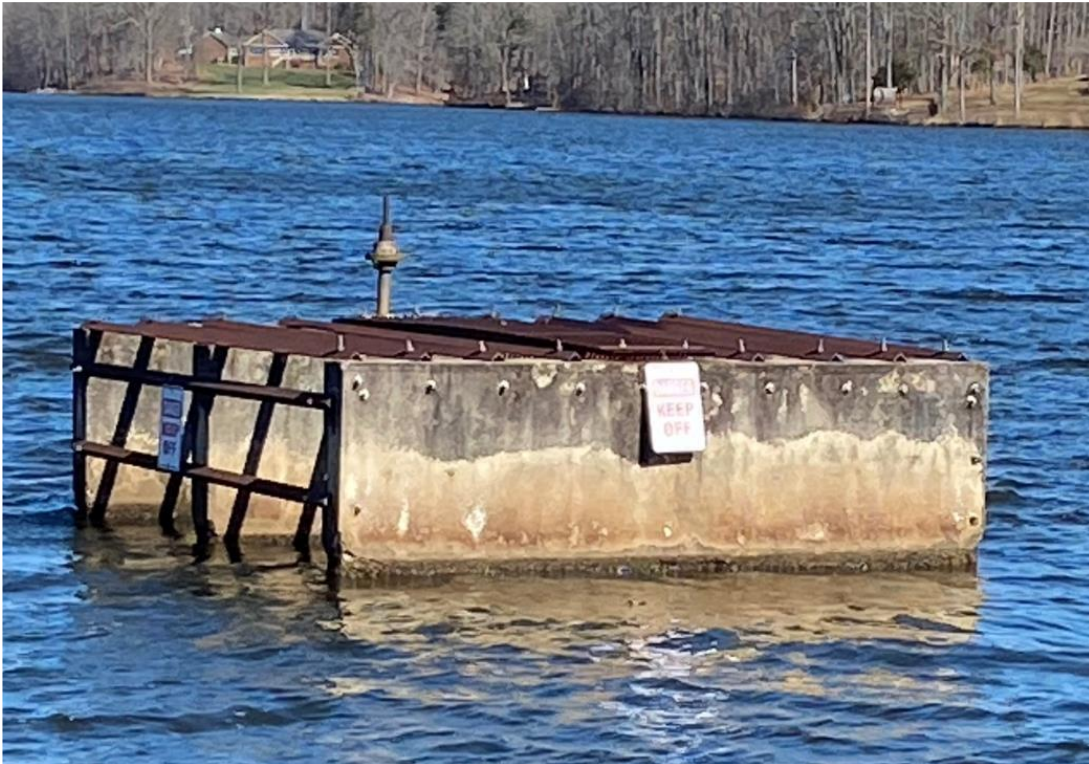
- Some minor areas of concrete spalling around the outside of the riser structure. No exposed rebar. Debris rack appears in good condition and operating as designed.

No action needed. Monitor.

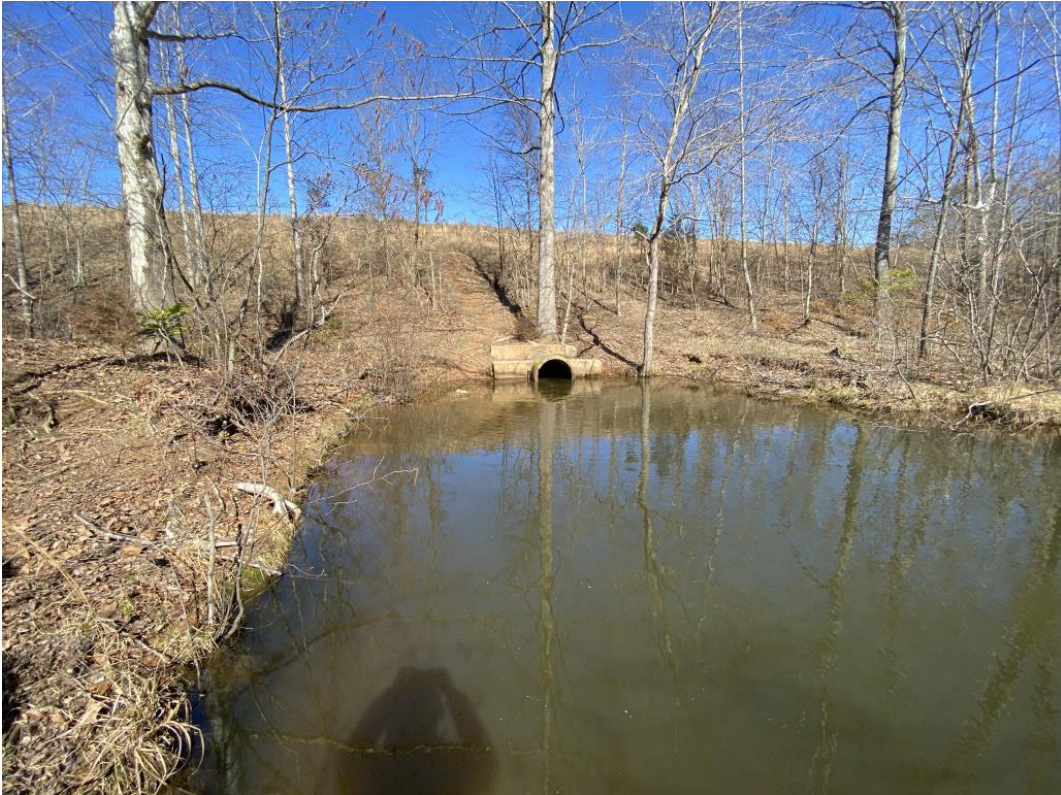
- Small trees and woody vegetation on embankment slope

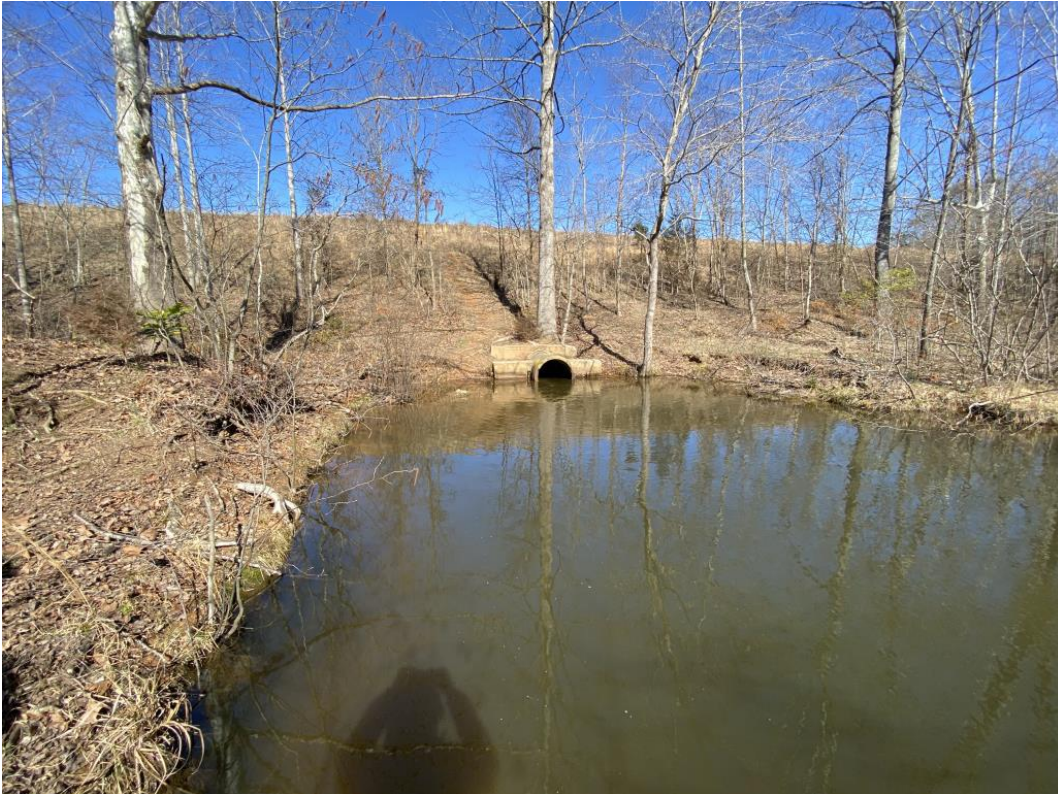
- Small trees and woody vegetation on embankment slope

Remove all trees and woody vegetation within 25 feet of the abutment except for the large tree at the outfall. Mow embankment twice annually.

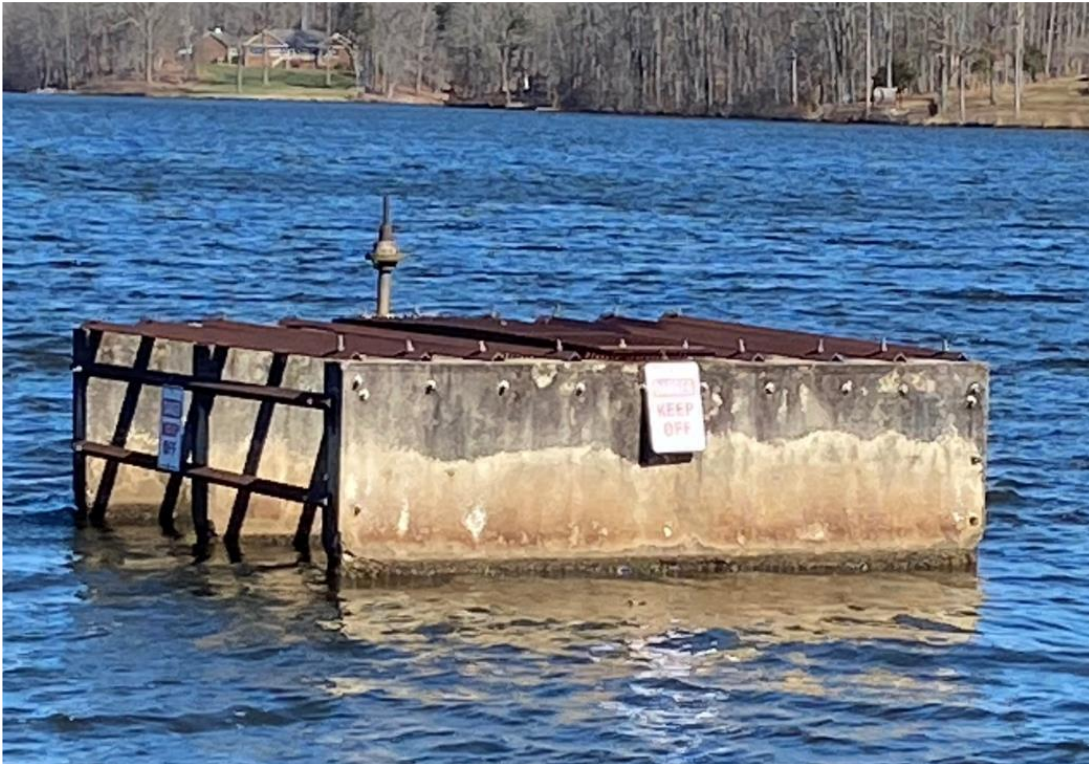
- Low level drain was not operated during the survey.

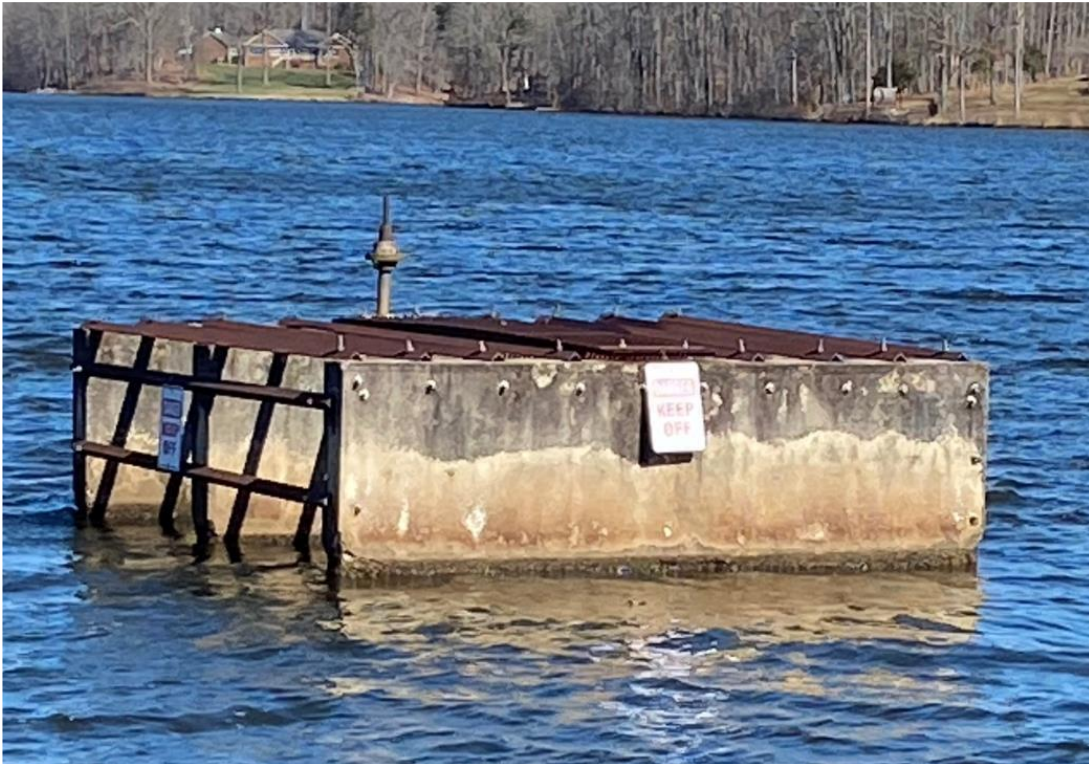
- Low level drain was not operated during the survey.

To obtain a Full Certificate the State (DCR) requires that we need to be able to lower the level of the dam 6" on demand, (not a legal requirement.) Many owners are sitting on this and just renewing the Conditional License every 2 yr.

State is offering 50% of the cost of reinstating this capability.

Possibilities: syphon, pumps, weir, additional valve.
